October 15, 2010

Subject: Hydrologic, Hydraulic, and Geotechnical Assessment for Argentine Mine / St. Louis Tunnel Sediment Settling Ponds, near Rico, Colorado  
Contract No. EP-W-05050, START 3, Region 8  
Project No.: 22241923

URS was also asked to conduct a site visit to observe the existing condition of select sediment settling pond embankments, specifically Pond 18. Our observations were to be limited to those visible features on the slopes, crest and down stream areas that appear to be related to embankment stability. Our primary focus was to be on drainage patterns, evidence of subsidence, erosion, seepage, and surface instability. The following summarizes our understanding of the historical operation of the settling ponds, our observations, followed by conclusions and recommendations. Photographs documenting the existing condition of the pond embankments are located in Attachment 4.

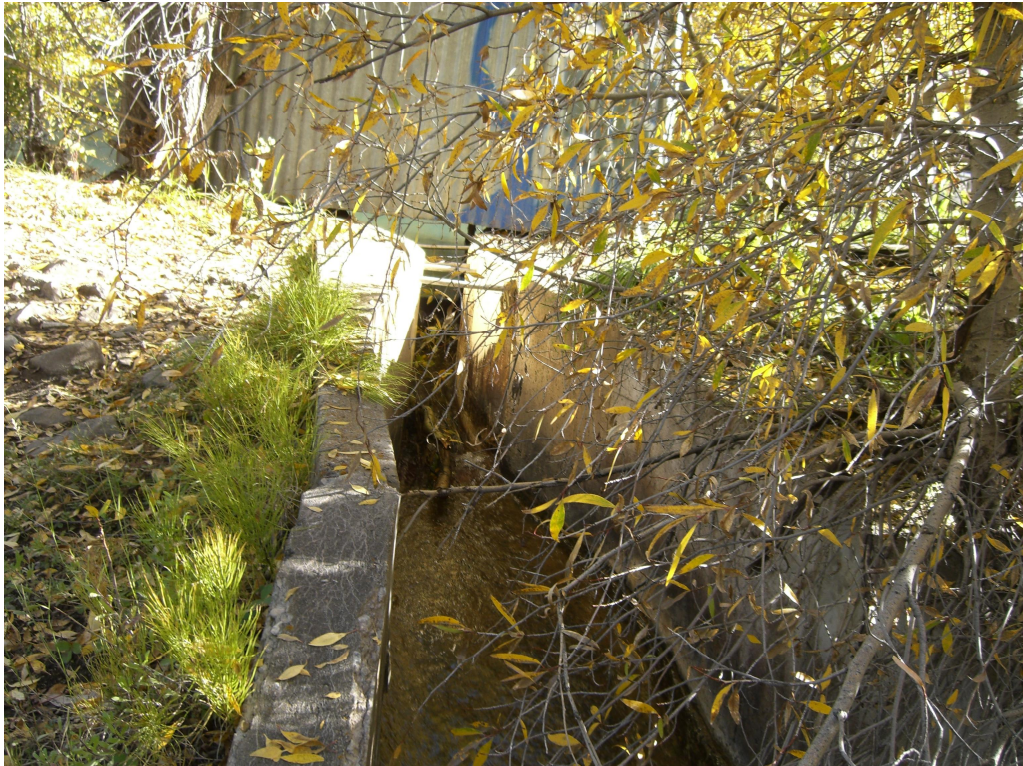
28. Discharge flume, facing upstream, Parshall flume in front.
